HENDRIKA JACOBA

Marine accident report on fall between quay and ship

29 MAY 2022

**MARINE ACCIDENT REPORT ON FALL BETWEEN QUAY
AND SHIP ON HENDRIKA JACOBA ON 29 MAY 2022**

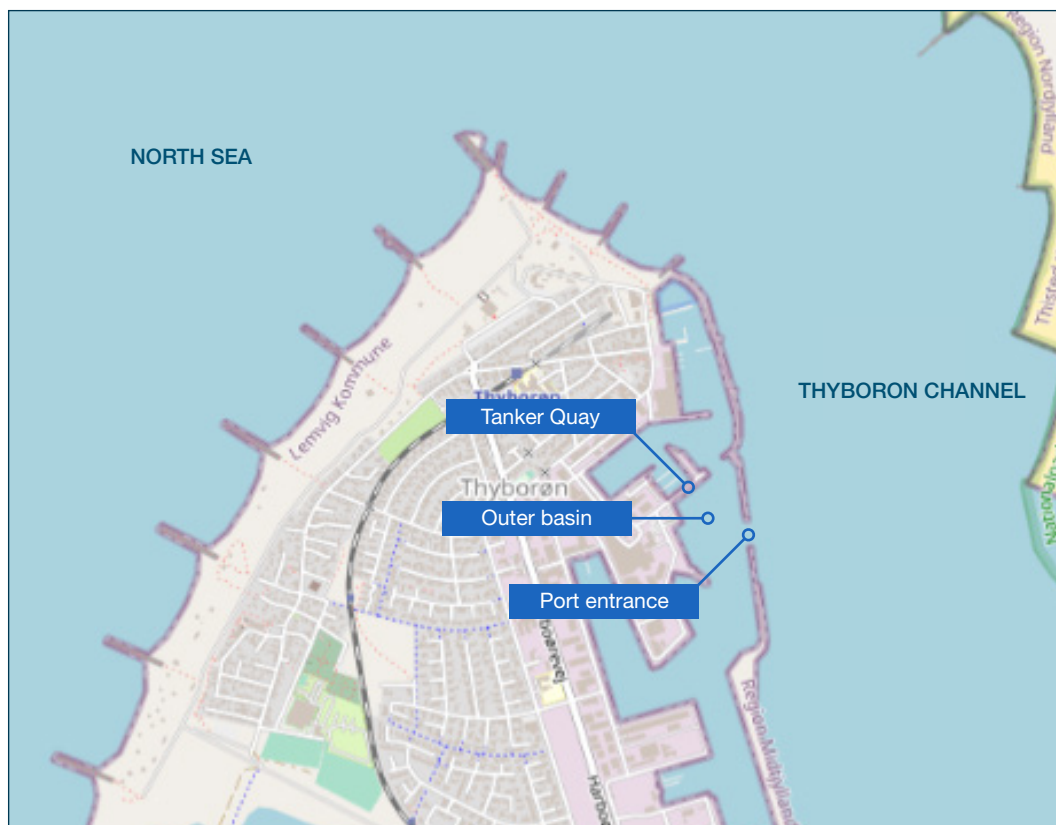
Figure 10: Thyboron Port.

Thyboron Port is located on the West Coast of Jutland, Denmark. The port entrance faces east in Thyboron Channel, sheltered from the North Sea (Figure 10). During northwesterly winds, waves and swell from the North Sea create residual wave patterns in the port area, especially in the outer basin which lay directly at the port entrance. Furthermore, northwesterly winds make the sea level in the port rise.
